## CASE STUDY 03 · VALIDATION

# Rapid Validation of an Excavation Pit

Transformer oil contamination in South Australia, excavated and validated in real time – so the pit could be backfilled the same day.

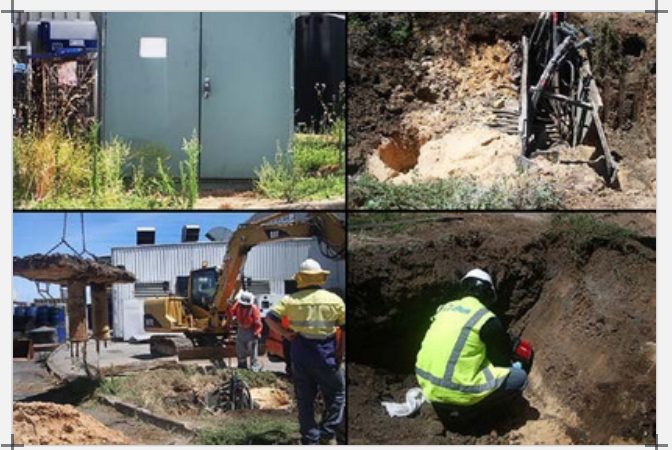
Excavation of the transformer footings, with RemScan measurements directing the extent of the dig.

The levels of TPH in the worst affected areas were up to 100,000 mg/kg. The Enviropacific Services Project Manager directed the extent of excavation until contamination levels in the walls and floor of the pit were below the target criteria of 1,000 mg/kg TPH as measured by RemScan.

The pit was then backfilled, and soil samples collected from each of the pit walls and floor were sent to a NATA-accredited laboratory for independent validation. A week later, the laboratory results confirmed the accuracy of the RemScan measurements – all samples returned TPH values well below the target criteria.
